# Electrical Infrared & Thermal Imaging Inspection 2026

Sample Facility (Demo)

| Report Title | IR Scan & Electrical Inspection 2026 |

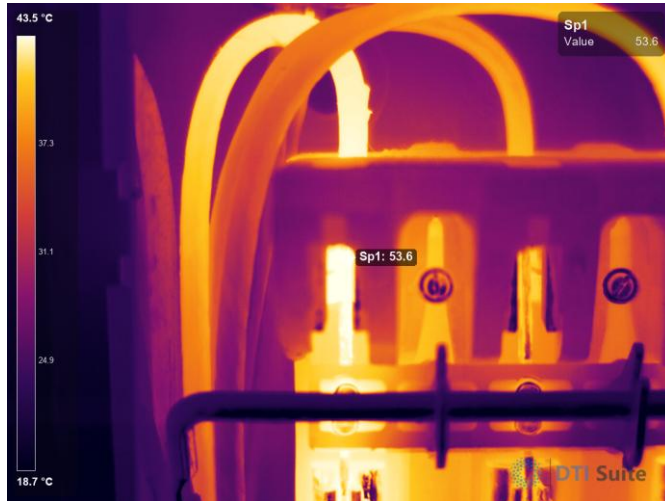
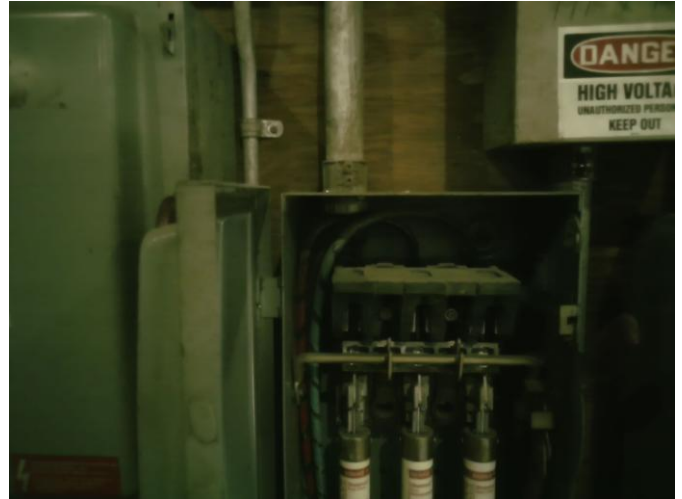
**Asset Tag No. 16115**  
**Fault Rating: Repair Immediately**

| No. | Asset | Label | Location | Max Temp | Problem | Recommendation | Severity | Page |
|---|---|---|---|---|---|---|---|---|
| <a href="#">1</a> | <a href="#">16115</a> | CRAC-1 | Head End | 53.6 °C | Extreme high temperature found. | Shut down equipment immediately. Notify equipment owner. | <b>Repair Immediately</b> | <a href="#">11</a> |

| Problem: | Extreme high temperature found. |

IR Scan is showing a high resistance connection on the Phase A, load side stak-on crimp connection for the main fan contactor. The current draw is balanced and the highest temperature is on the stak-on crimp indicating a failing crimp connection. Recommend replacing stak-on crimp.  
 Current Draw: Phase A: 16.5A, B: 16.5A, C: 16.5A

| Recommendation: | Shut down equipment immediately. Notify equipment owner. |

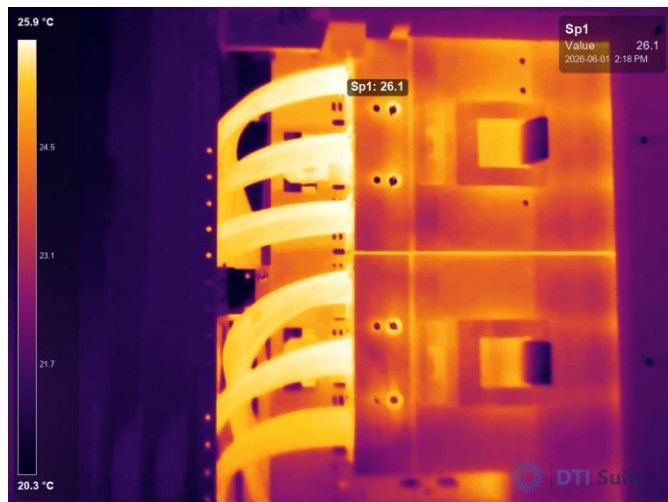
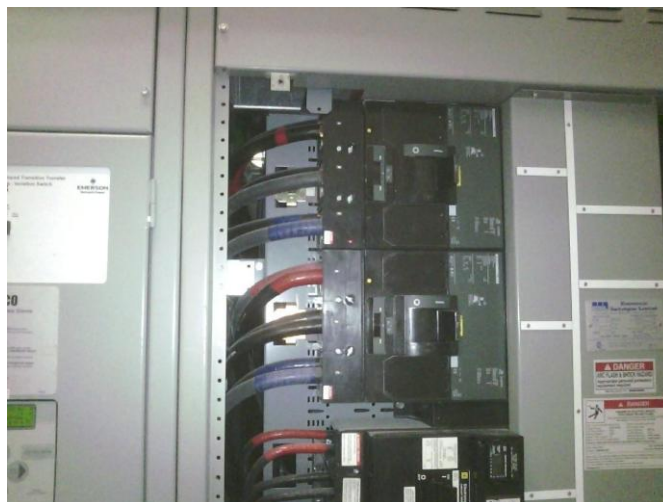
Asset Tag No. **246861**  
 Fault Rating: **Reference Only**

IR Ok, temperature correlates to the current draw. Photo is for reference only.  
 Feeder Dist. RDP-1:  
 Current Draw: Phase A: 206A, B: 200A, C: 195A  
 Feeder Dist. RDP-2:  
 Current Draw: Phase A: 205A, B: 201A, C: 200A

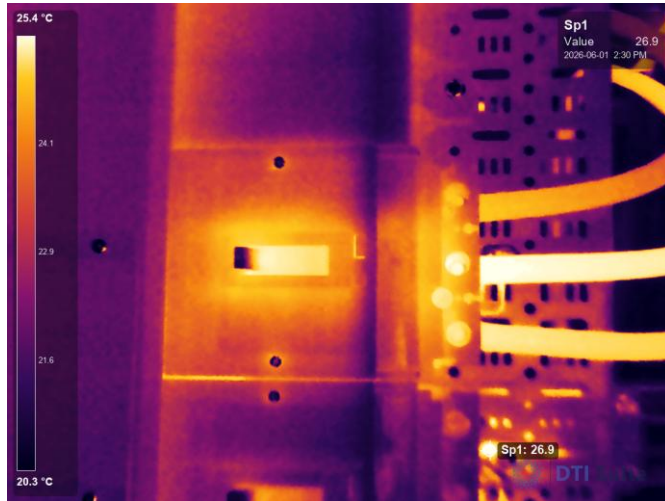
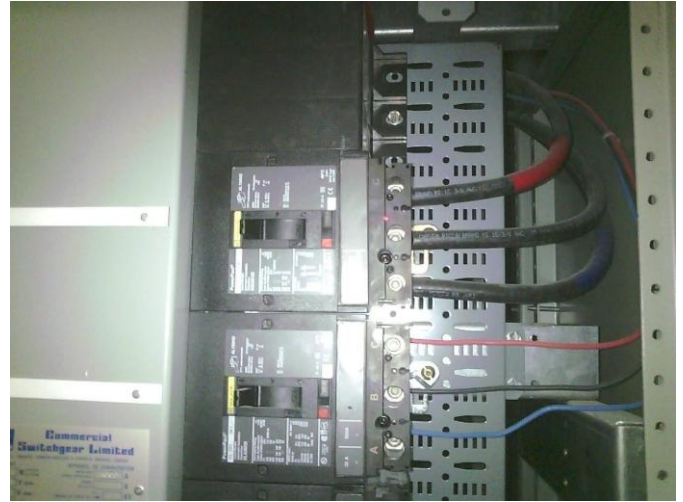
Asset Tag No. **246871**

| Problem: | Suspected loose connection. |

IR Scan is showing a high resistance connection on the line side screw of the 20A breaker for CCT 3: Hub room lights. Technician checked screw last year which is stripped and un able to be tightened.

| Recommendation: | Replace breaker. |

\*Screw has been replaced. Re scan has been performed and no thermal anomaly was detected. No further repair required, will review next IR Scan.

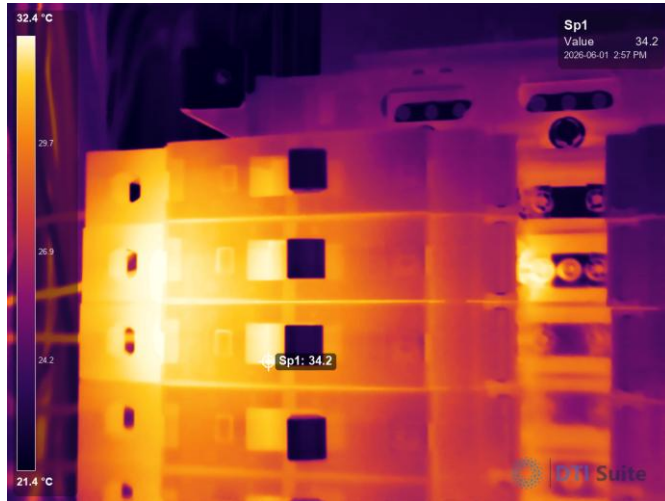
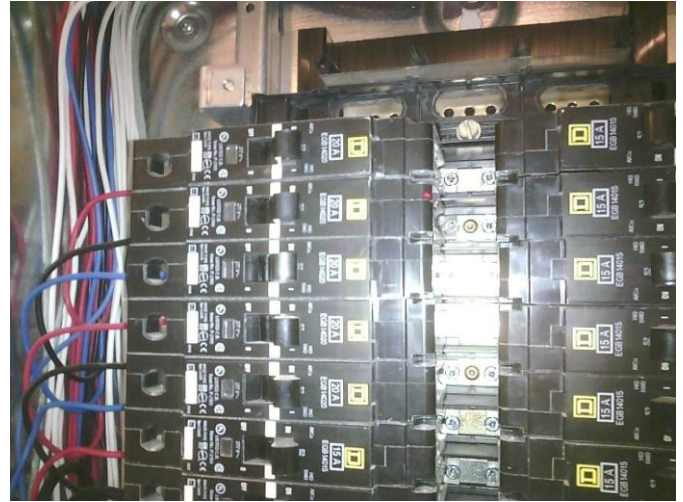
Asset Tag No. **246882**

| No. | Asset | Label | Location | Max Temp | Problem | Recommendation | Severity | Page |
|---|---|---|---|---|---|---|---|---|
| <a href="#">2</a> | <a href="#">246882</a> | BDFB 401 | Head End | 32.5 °C | High temperature connection. | Un-terminate, clean connection point, re-terminate and torque to manufacturers recommendations. | <b>Potential Problem</b> | <a href="#">14</a> |

IR Scan is showing a higher than normal temperature on the wire labeled 507-49/B1/-48V where it connects to -48 Bus B1. The temperature on this connection is significantly higher than any other scanned at this Hub. Due to the highest temperature being at the termination point it is recommend to check connections.  
\*Lug has been replaced and relocated to new bus. Re scan performed and no thermal anomaly was detected. No further repair required, will review next IR Scan.

Asset Tag No. 246882  
Location: Head End  
Label: BDFB 401  
Equipment Type: DC Panel  
Rating: 48VDC, 800A  
Problem: High temperature connection.  
Recommendation: Un-terminate, clean connection point, re-terminate and torque to manufacturers recommendations.
